# BELL\_STIL

01202650  
01202651

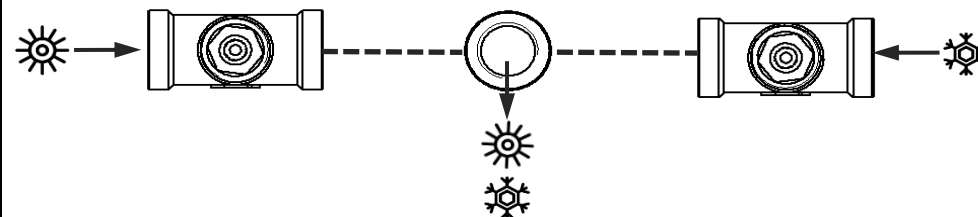
3

| | | BAR | 1 MÍN | |
| | | | 5 MÁX | |
| | | ° C | 50 ° | |
| | | | 80 ° | |
| | | > 5 BAR | | |

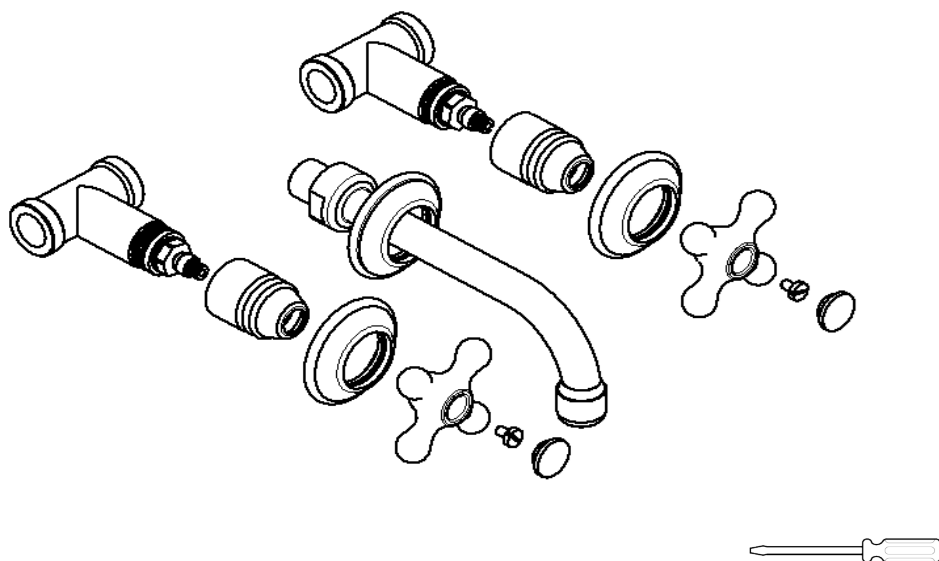
4

IMPRESINDIBLE Y OBLIGATORIO VERIFICAR LA ESTANQUEIDAD Y EL CORRECTO FUNCIONAMIENTO DE LA PIEZA ANTES DE PONER EL REVESTIMIENTO.

VERIFYING TIGHTNESS AND CORRECT PERFORMANCE OF THE PIECE BEFORE TILING IS INDISPENSABLE AND COMPULSORY.

IL EST INDISPENSABLE ET OBLIGATOIRE DE VÉRIFIER L'ÉTANCHEITÉ ET LE BON FONCTIONNEMENT DE LA PIÈCE AVANT DE POSER LE REVÊTEMENT.
