# LINOX

55003104

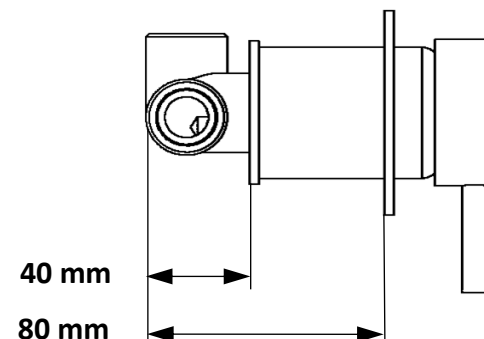
2

40 mm

80 mm

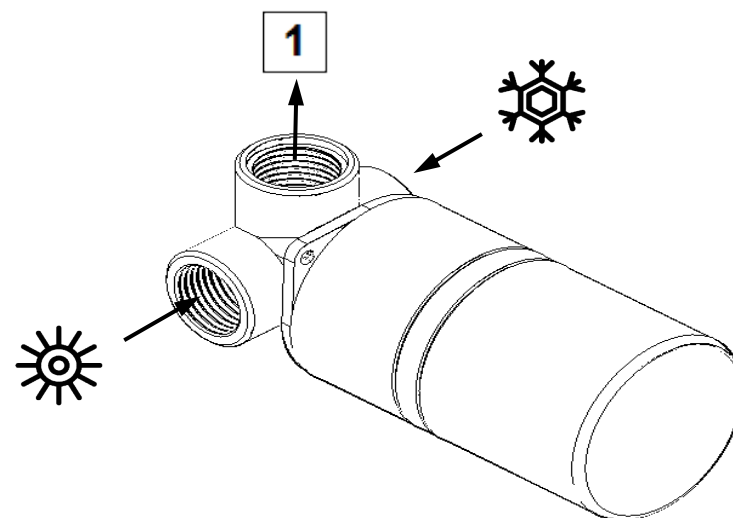
**BAR**

**1 MÍN**

**5 MÁX**

**1 A 3 BAR**

**° C**

**50 °**

**80 °**

**50° A 65°**

**> 5 BAR**

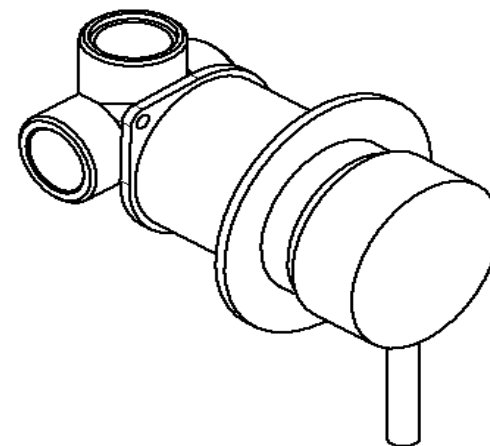
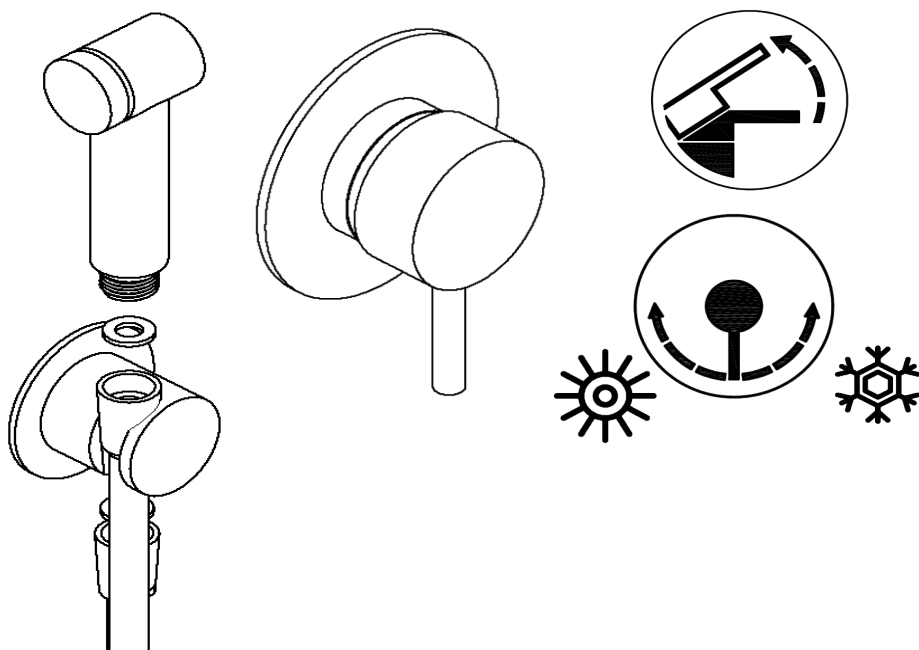
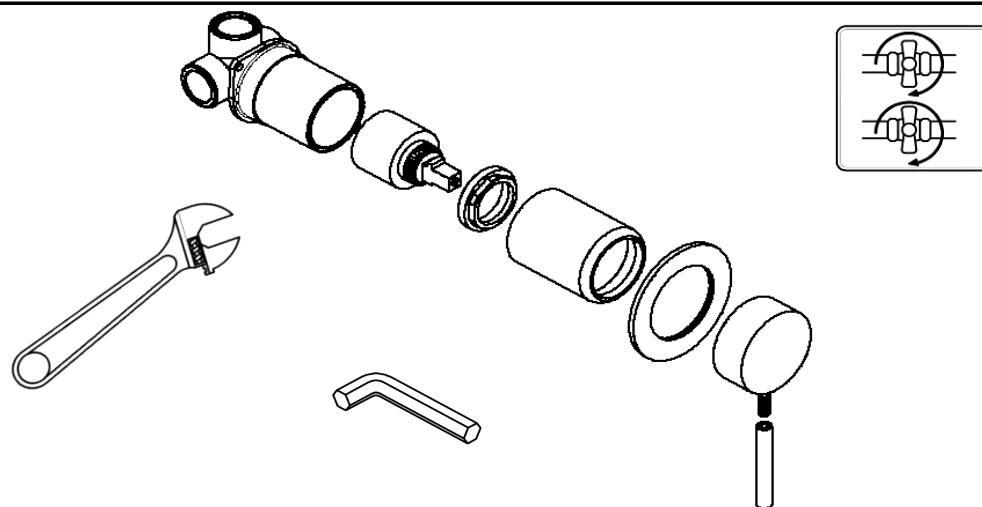
This diagram shows an exploded view of a mechanical assembly. The components are arranged in a disassembled state to show their relative positions and how they fit together. The parts include a central cylindrical component with a flange, a smaller cylindrical component, a large circular flange, a small ring, a small cylindrical component, a small rectangular component, a small cylindrical component, a small rectangular component, and a small cylindrical component. The diagram is a line drawing with no shading or color.

**IMPRESINDIBLE Y OBLIGATORIO VERIFICAR LA ESTANQUEIDAD Y EL CORRECTO FUNCIONAMIENTO DE LA PIEZA ANTES DE PONER EL REVESTIMIENTO.**

**VERIFYING TIGHTNESS AND CORRECT PERFORMANCE OF THE PIECE BEFORE TILING IS INDISPENSABLE AND COMPULSORY.**
